# RG-Switch (for RGOS 11.X) FAQs V1.1

# 1 Overview

This document describes usage limitations of switches using the RGOS 11.x software platform and problems that frequently arise during deployment, so as to provide guidance for after-sales engineers to deploy and implement products and improve the deployment efficiency and quality.

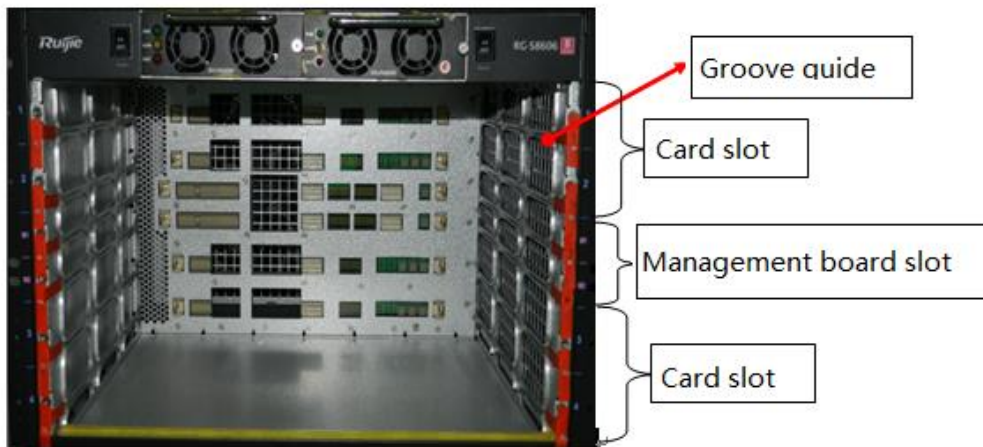
Step 1: Confirm the models and slots of cards and supervisor modules, as well as positions of guide rails.

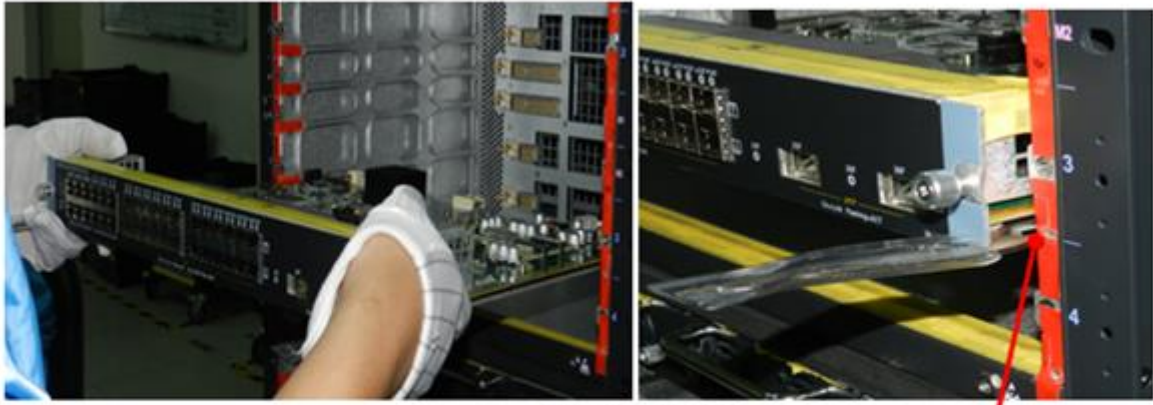
Step 3: Hold the card (supervisor module) with hands, keep it parallel to the chassis, and insert it into the correct slot till it is locked by the self-locking lever.

Lateral chassis

Management board is stuck

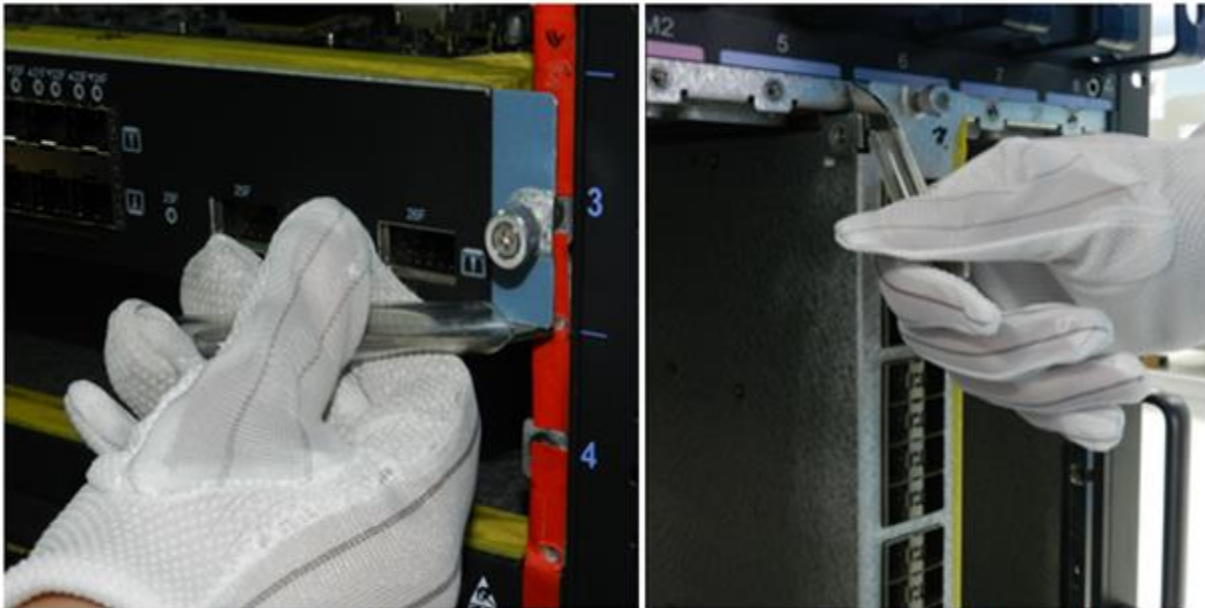
Step 4: Hold the self-locking lever, insert the card (supervisor module) along the motion trail of the self-locking lever till the card (supervisor module) is completely inserted into the chassis.

Lateral chassis

Longitudinal chassis

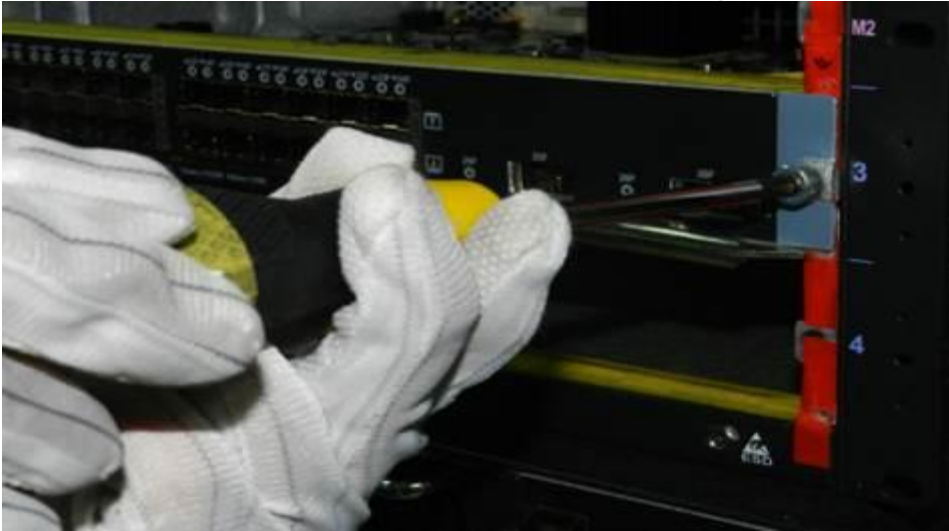
Step 5: Use a screwdriver to tighten screws on the left and right sides of the card (supervisor module).

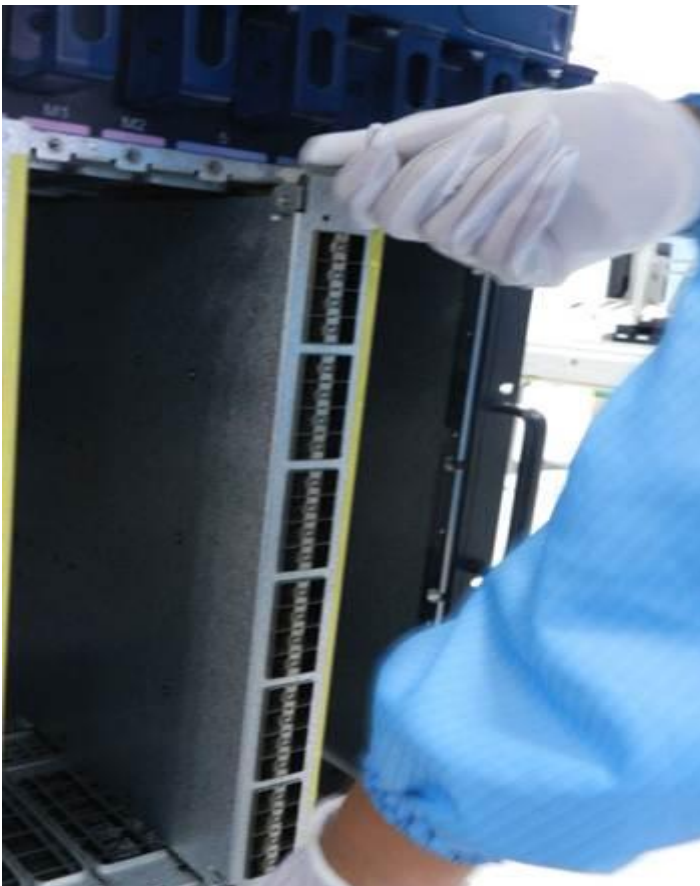
Step 1: Turn the self-locking lever to a position vertical to the chassis.

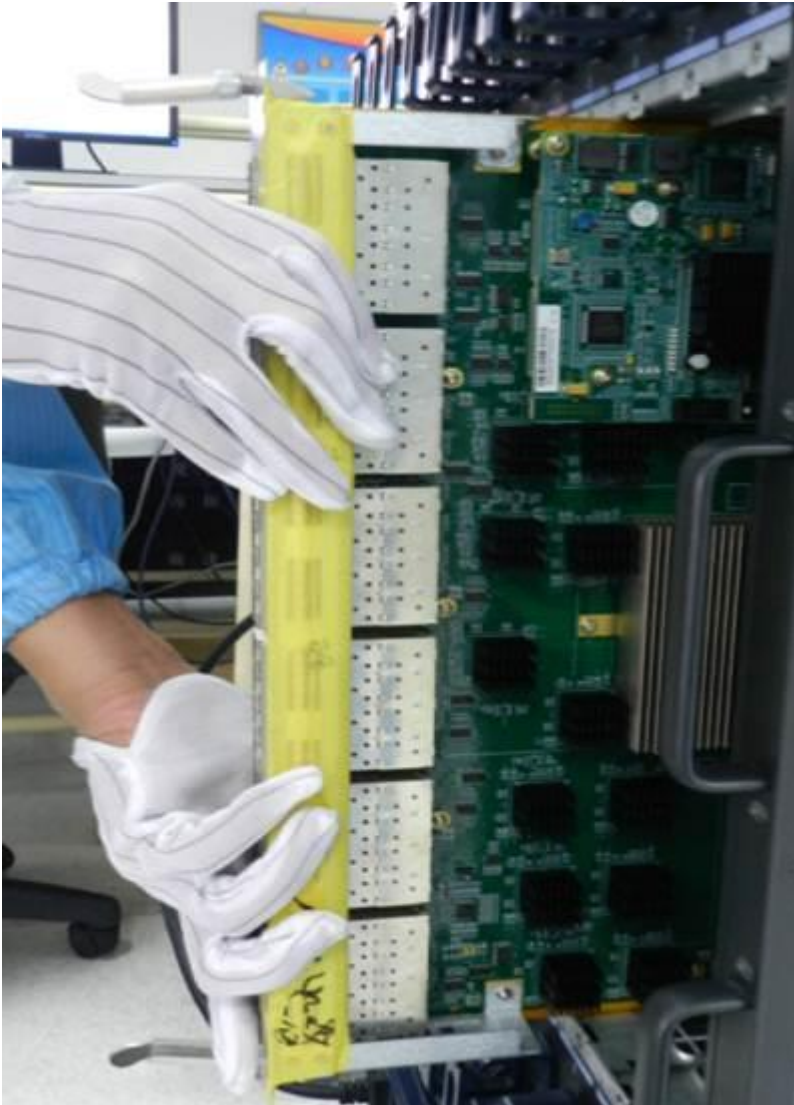
Step 2: Hold the filler panel of the card (supervisor module) with hands and gently pull it out in a direction parallel to the guide rail.

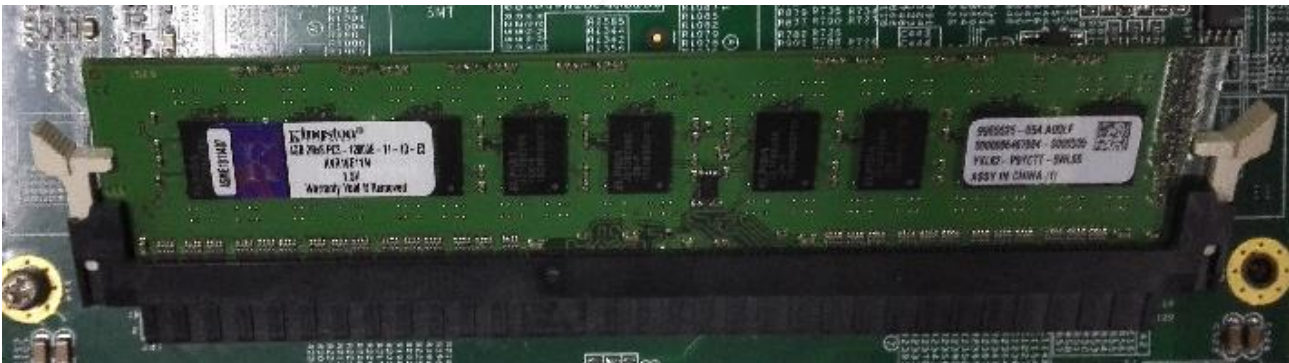
All CM cards in high-end switches that use obliquely inserted memory module sockets, as shown in the following figure.

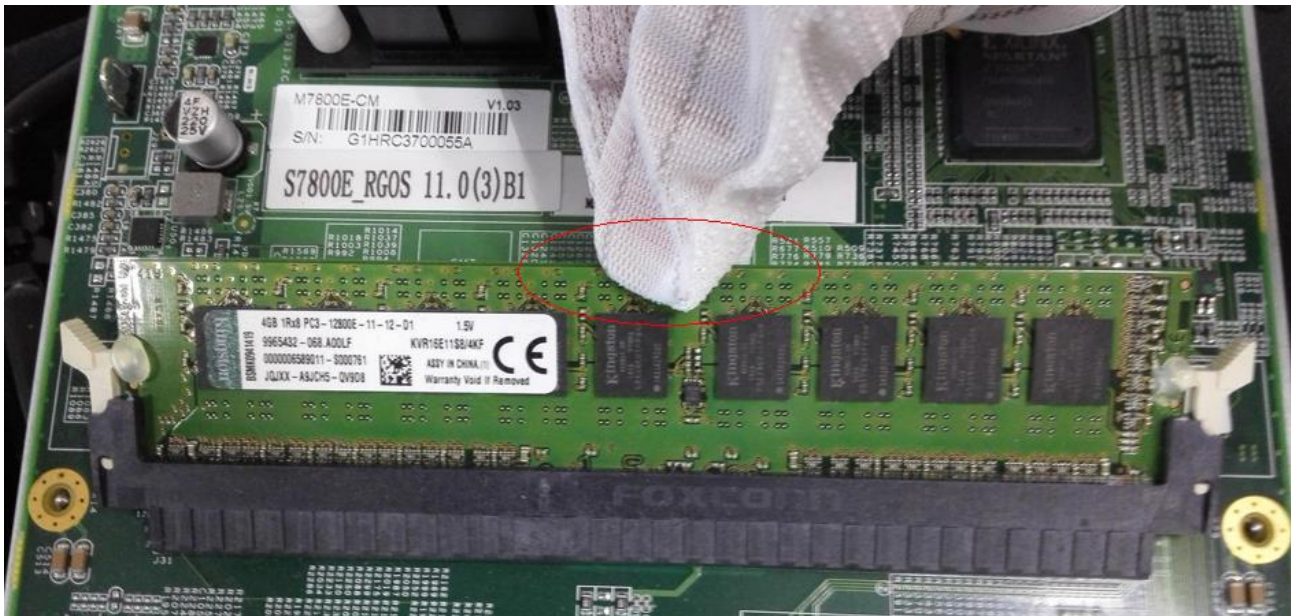
Figure 2

Step 2: After wearing ESD gloves or an ESD wrist strap, hold the edge in the middle of the memory module where no component resides (as shown in Figure 2), shake the memory module top down along the direction vertical to the memory module plane (as shown in Figure 3), with the amplitude smaller than 5 mm, to prevent damage to the memory module and socket.

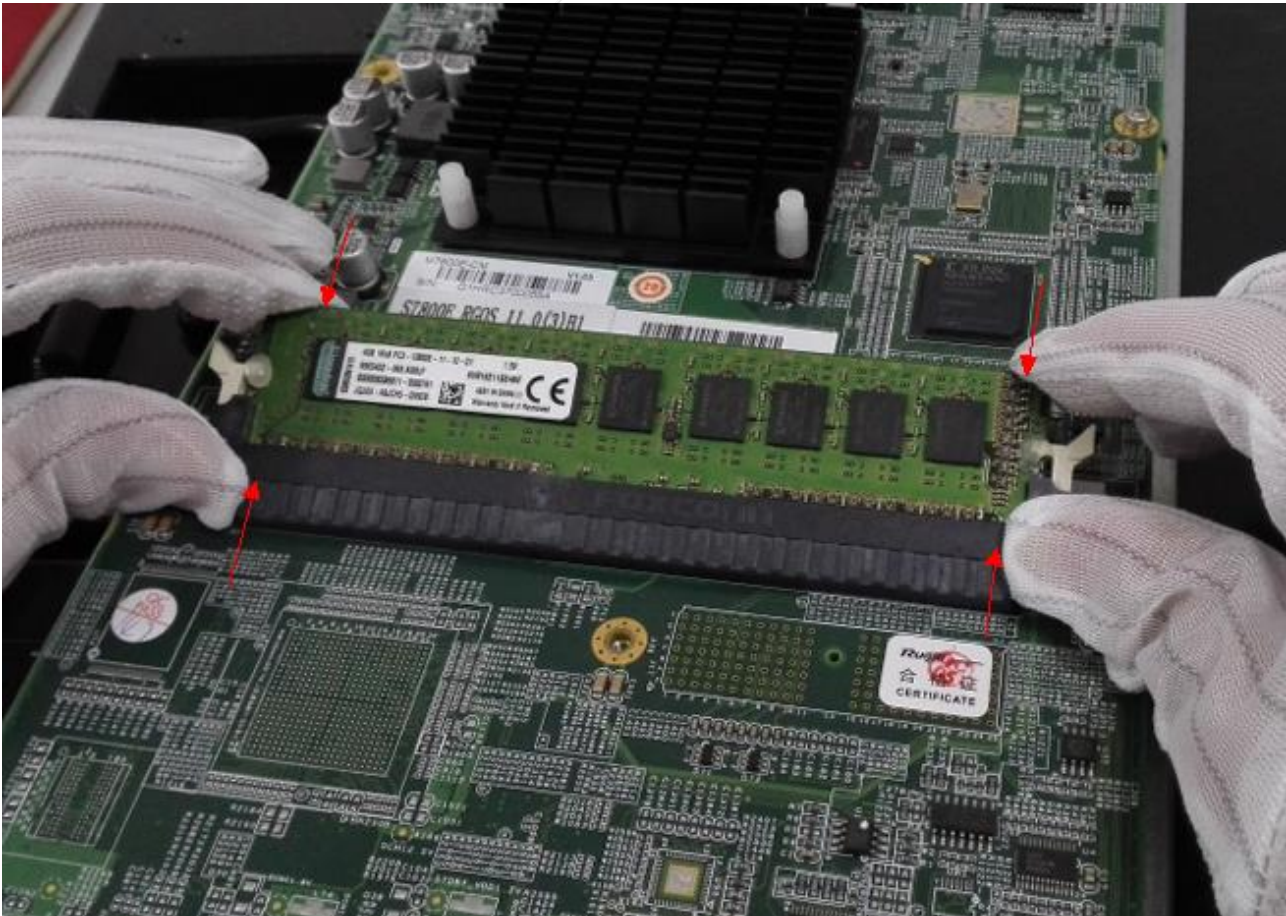
Figure 4

Step 3: Hold both ends of the memory module and socket with index fingers and thumbs, and press the memory module into the socket with force along the direction parallel to the memory module, as shown in Figure 4.

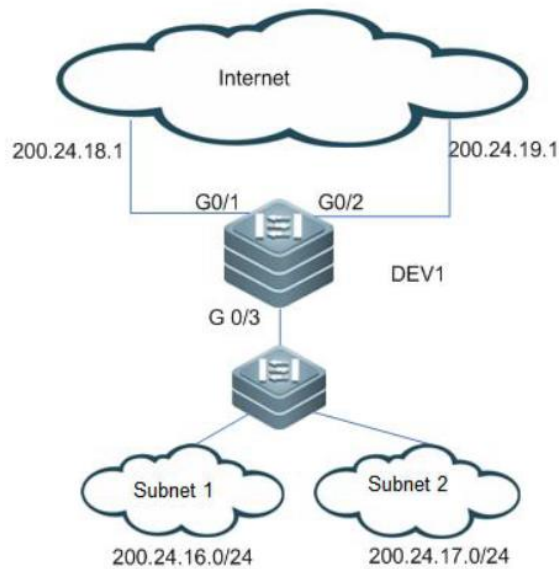
As shown in the Figure-1, DEV1 connects to subnets 1 and 2 through G0/3, and connects to the Internet through G0/1 and G0/2 with the next hop of 200.24.18.1 and 200.24.19.1, respectively. Subnet 1's segment is 200.24.16/20 and subnet 2's segment is 200.25.19.1.

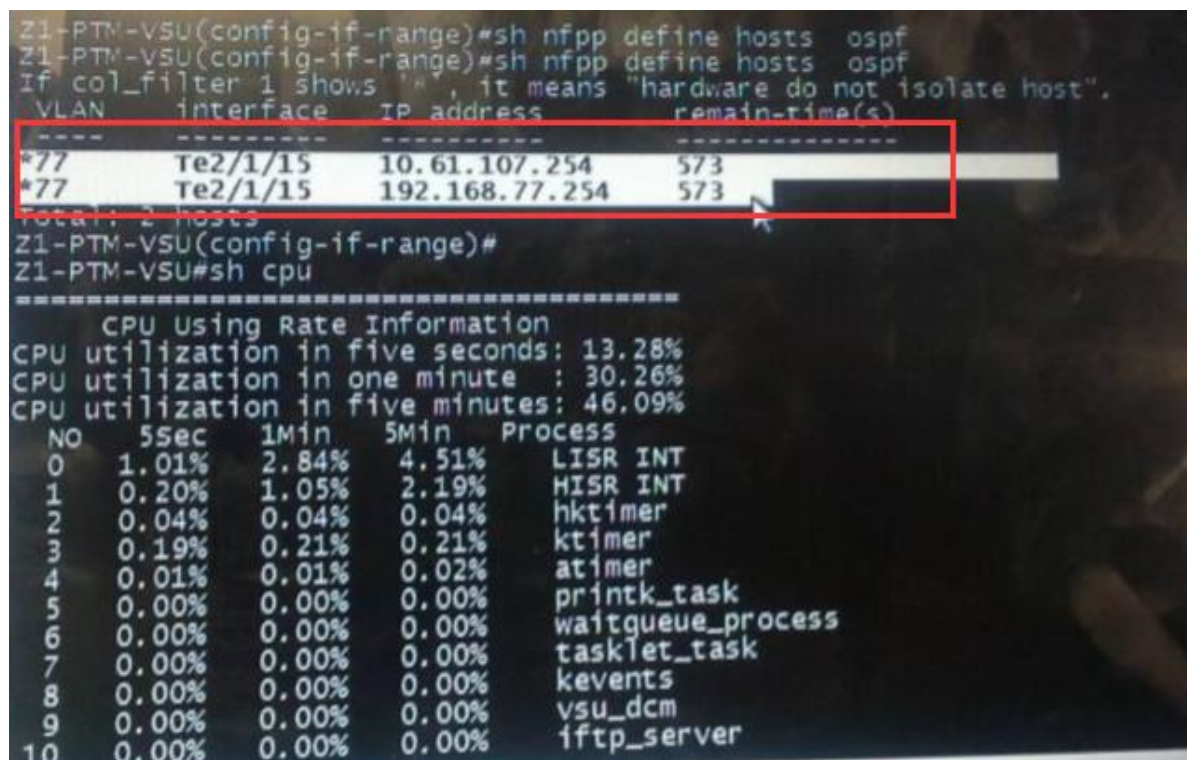
2. After the preceding commands are configured, check whether the CPU attacks of the device are eliminated and check information about the attack source isolated by NFPP. It is found that attacks are initiated in VLAN 77. Perform the shutdown operation on SVI 77, find out the attack source further, and take actions accordingly.

The screenshot shows a terminal session on a Z1-PTM-VSU device. The user enters the command `sh nfpp define hosts ospf` twice. The output shows a table of isolated hosts:

VLAN	interface	IP address	remain-time(s)
*77	Te2/1/15	10.61.107.254	573
*77	Te2/1/15	192.168.77.254	573
