Switch Troubleshooting Guide V1.0

This article provides a systematic approach to identifying and remedying problems that may arise as you use your RG-S8600E Switch over a period of time. This guide is not intended to replace configuration guide or to be an all-inclusive guide for every application. Rather, it is an attempt to provide you with the knowledge and skills necessary to correct the most common issues that you may encounter.

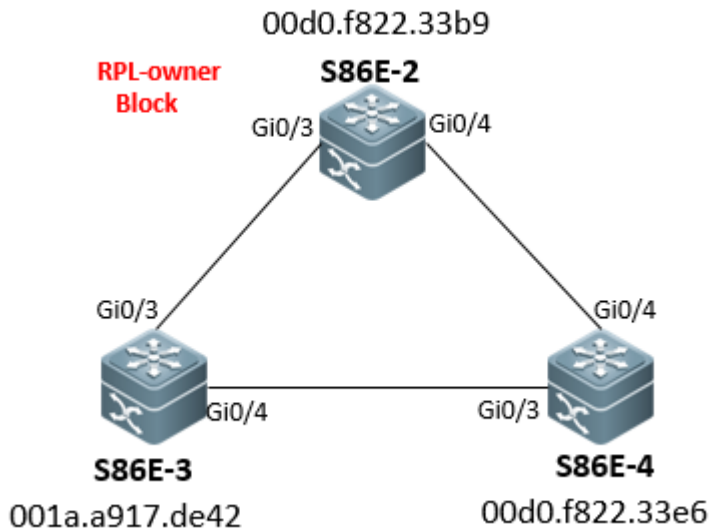
Step2: Check whether the ERPS interface is modified during the operations. If the ERPS interface is directly modified without being shut down, convergence will fail and then a loop will occur.

The topology is as follows:

Scenario 1: The topology is shown in the preceding figure.

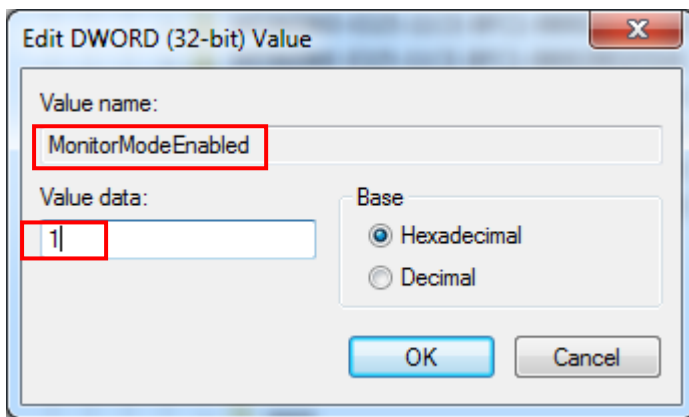
Create another file in the same way, name it **MonitorModeEnabled**, and change the value data also to 1.
